“Bullnose” curved carport addition to return verandah villa.

Specification

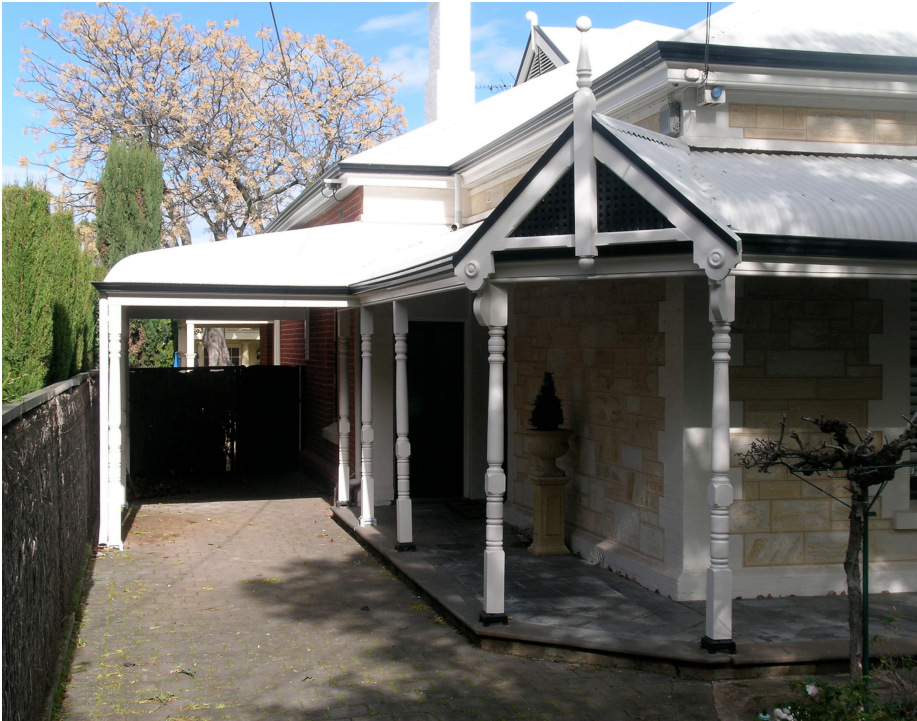
- Posts: 112 mm x 112 mm LOSP treated pine, specially “turned” to match existing verandah posts.
- Fascia: 230 mm x 42 mm LOSP treated pine, with beaded edge .
- Curved rafters: Cut from 45 mm thickness L.V.L. beams.
- Purlins: 140 mm x 42 mm LOSP treated pine.
- Roofing: 0.60 mm Colorbond steel curved to match existing “bullnose” verandah sheets .
- Gutters: “OG” profile pre-painted “Colorbond steel.
- Hip capping: “Acrylead” formed over PVC electrical conduit (to maintain integrity of rolltop)
- Valley gutter: formed from “Acylead”.

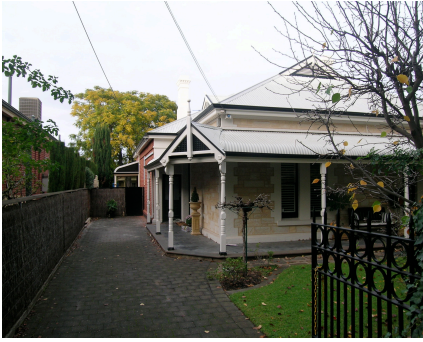
The owners wanted a carport but did not want to lose the characteristic features of their return verandah villa.

Unable to find any carport additions that met their requirements they were concerned that maybe it was not possible to achieve .

I prepared quotations for several options; each retained the return verandah and the gable corner; and integrated the carport to the existing verandah with a valley.

We had the posts specially “turned” to match the existing verandah posts.

The fascia boards were machined with an “old style beaded” bottom edge, to match the existing verandah fascias.

The “bullnose” roofing was curved to match the bullnose curve on the existing verandah.

The hip setback from the front fascia matches the width of the existing verandah as this ensures the roof slope on the front elevation matches the roof slope of the existing verandah.

The resulting carport addition blends with the existing verandah and retains the home characteristic features.

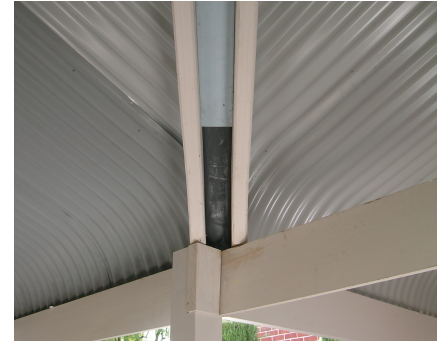
Valleys are formed from “Acrylead”

The valley rafter arrangement produces a valley that is exceptionally strong and can support a person who may need to access the roof for some reason.

The valley also has the capacity to discharge water efficiently.
