“Bullnose” curved verandah addition to return verandah villa - to re-instate the original roofline.

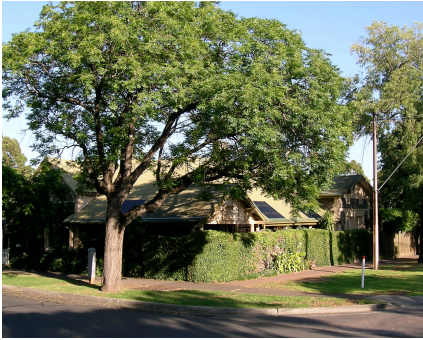
The owners wanted to re-instate the characteristic features of their return verandah villa.

The original bullnose verandah had been removed when the home was re-roofed about 30 - 40 years ago.

During the re-roofing process the roofing from the main roof was extended across the verandah space and a large gable was constructed on the corner.

The owners also wanted to change the roof colour from the "Bronze Olive" to a colour more sympathetic to the home's period.

We replaced the "Bronze Olive" roofing with "Woodland Grey" Colorbond. The new "OG" profile gutters were "Monument" Colorond.

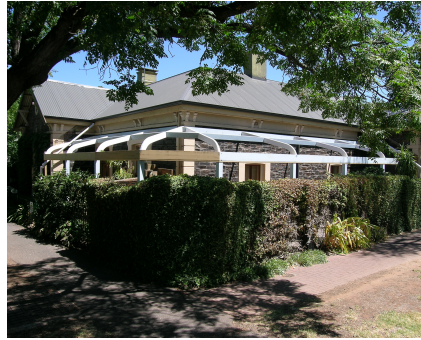
The new verandah frame incorporated bullnose shaped rafters, and intermediate purlins. The rafters and purlins provide support for the bullnose roofing. These was required because the verandah width exceeded the 1800 mm nominal maximum width for bullnose verandahs without rafter / purlin support. The additional support was also desirable because the roof will be accessed regularly for gutter cleaning.

The rafters are shaped on both the top and bottom and fit neatly against the underside of the bullnose sheets; enhancing the appearance.

The fascia boards were machined with an "old style beaded" bottom edge, to replicate the traditional fascia style.

The "bullnose" roofing was curved to match the bullnose curve on the existing verandah.

The hip setback from the front fascia matches the width of the existing verandah as this ensures the roof slope on the front elevation matches the roof slope of the existing verandah.

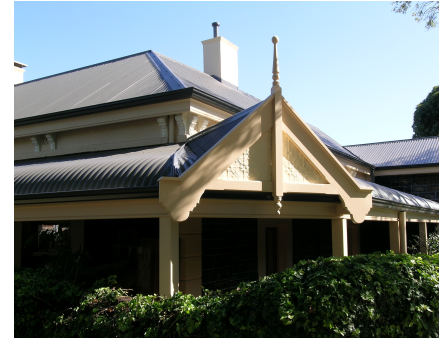
The owners were also keen to have a gable at the corner of the bullnose verandah.

We created a "false" gable. i.e. the gable sits above the bullnose verandah roofing. The bullnose roofing continues under the gable.

The gable incorporates several features typical of the home's period: -

Decoratively shaped ends on the barge boards.

Embossed metal (aluminium) gable infil.
Full length finial.
